# Manhole Inspection Summary

Manhole # S25II\_049MH

Insp Date: **8/29/07 10:12 AM**

**Location** Address: **2028 MCCULLOH ST**

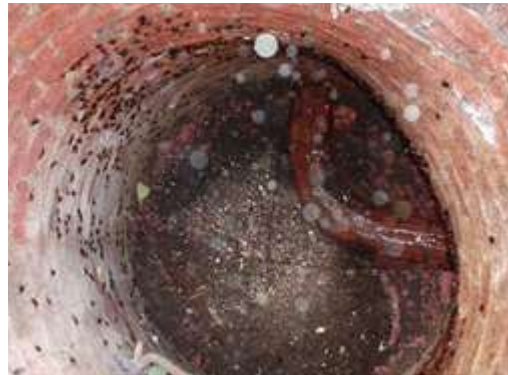
Top View

Bench debris.

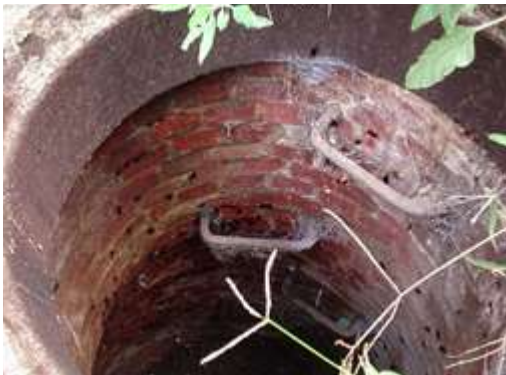
Defect

Frame leaks. Adjustment, Corbel and Barrel infiltration.

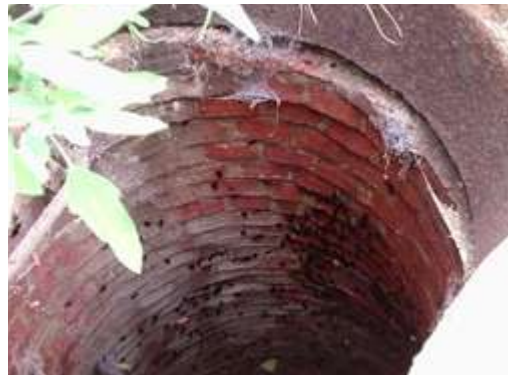
Defect

Frame leaks. Adjustment, Corbel and Barrel infiltration - other side.

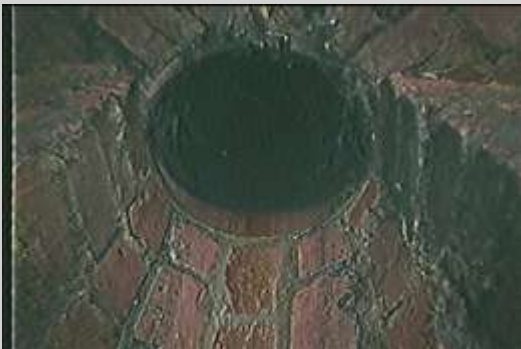
### 8 in. Circular Gravity Sewer Pipe In @ 3 O'Clock

Infiltration: **Evidence** Pipe Seal Cond: **Unknown**
